Human Medical Thermography

A technology update for professionals

James S. Campbell, EE, MD, MEDesign LLC, Pfafftown, NC.

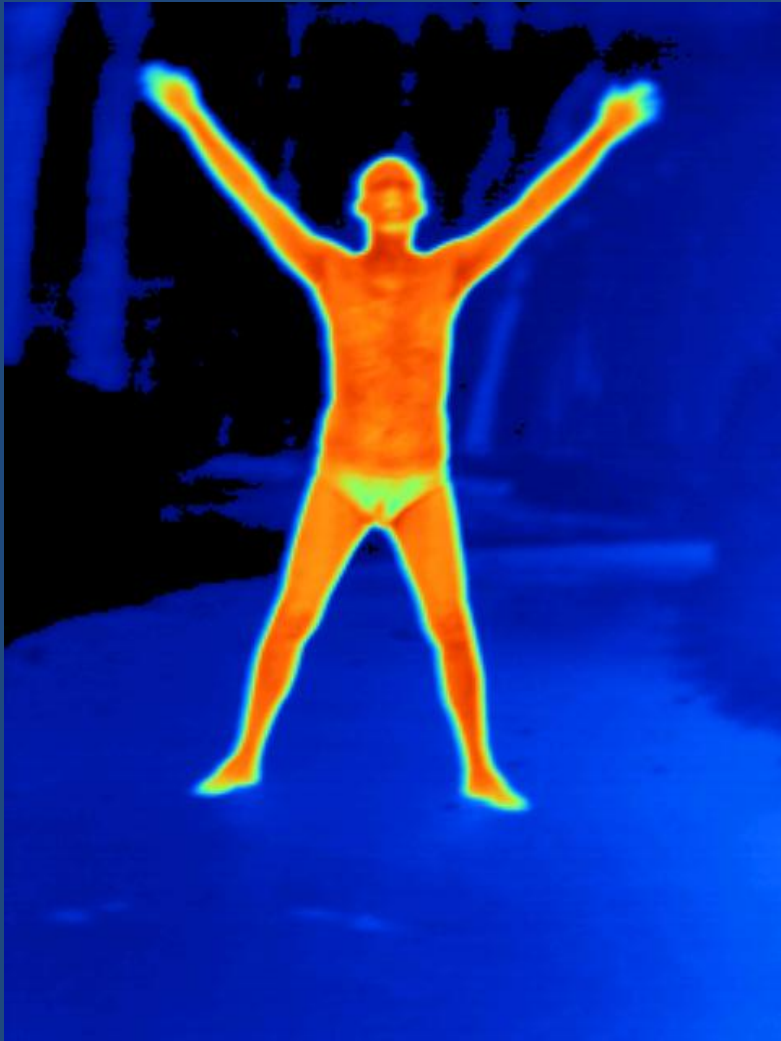
Warm man standing outside on a 40 °F winter night.

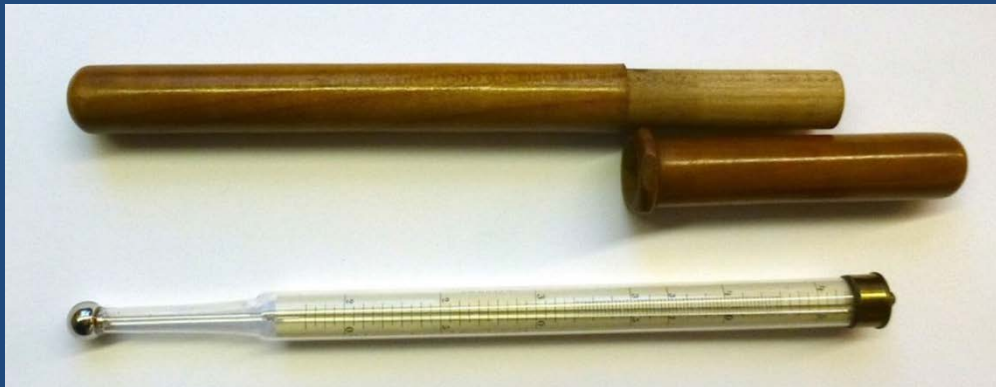
A Wunderlich thermometer, 10 inches long, with wooden case. Axillary temperatures took 30 minutes. Photo courtesy of medhxtour.

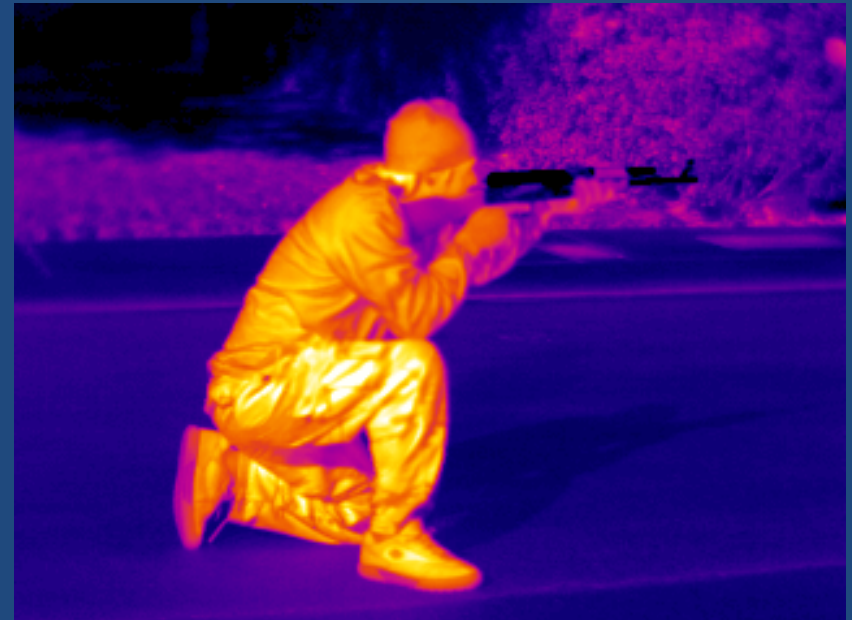
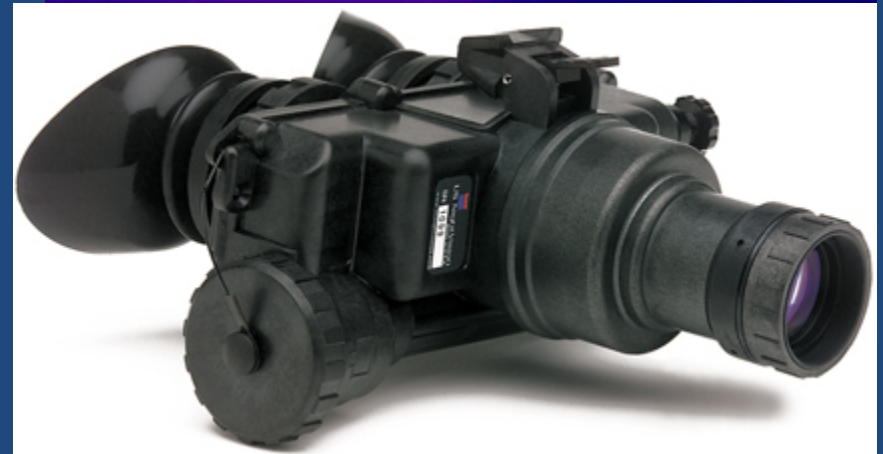
Detector: 320 x 240 Focal Plane Array, Vanadium Oxide (VOX) uncooled microbolometer.

Refresh Rate: 60 frames/sec

Spectral Band: 8 μm to 14 μm

Thermal Sensitivity:
 ≤ 0.050 $^{\circ}\text{C}$ at 30 $^{\circ}\text{C}$
Accuracy ± 2 $^{\circ}\text{C}$ or ± 2 %

Germanium Lens, Manual Focus

Spatial Resolution: 1.3 mrad

Focus Distance: 0.15 m – Infinity.

Actual specifications of the
Fluke Ti-55 IR Camera,
2007.

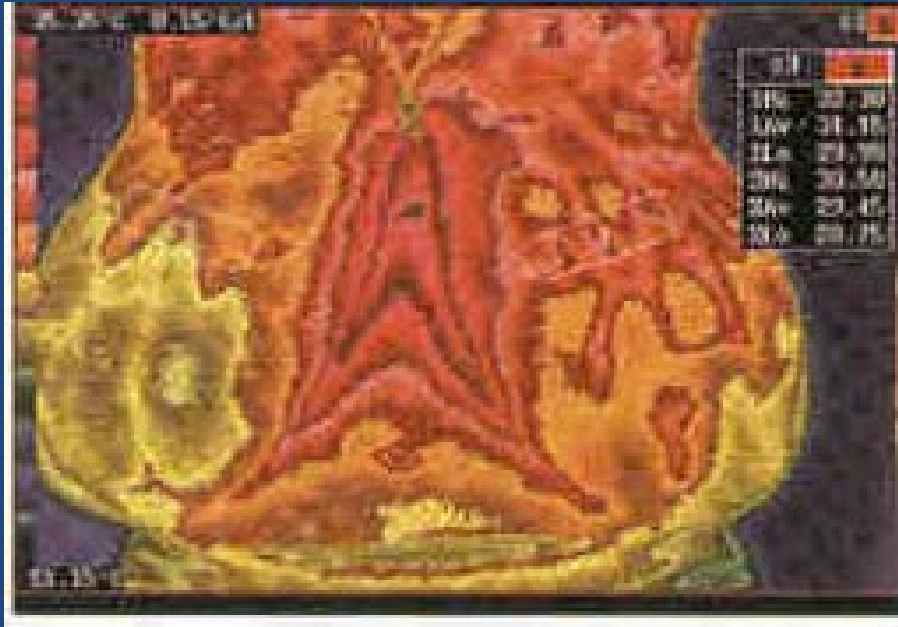
IR Image from 2000 Ville Marie Study taken with a Bales thermal scanner.

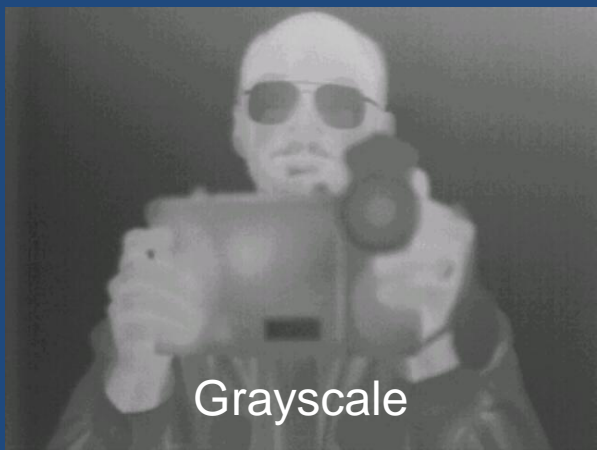
IR Images are Grayscale
but giving the image false color is useful for various tasks.

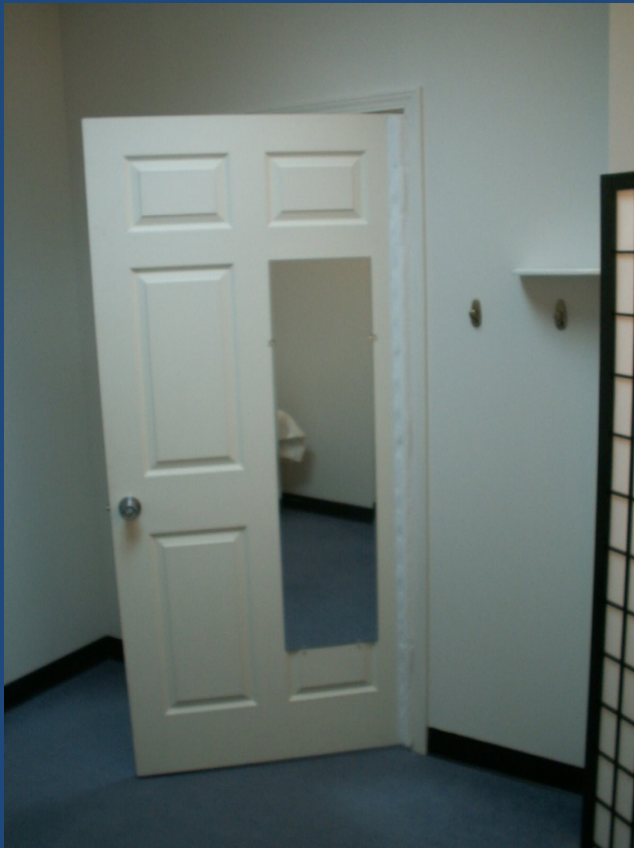
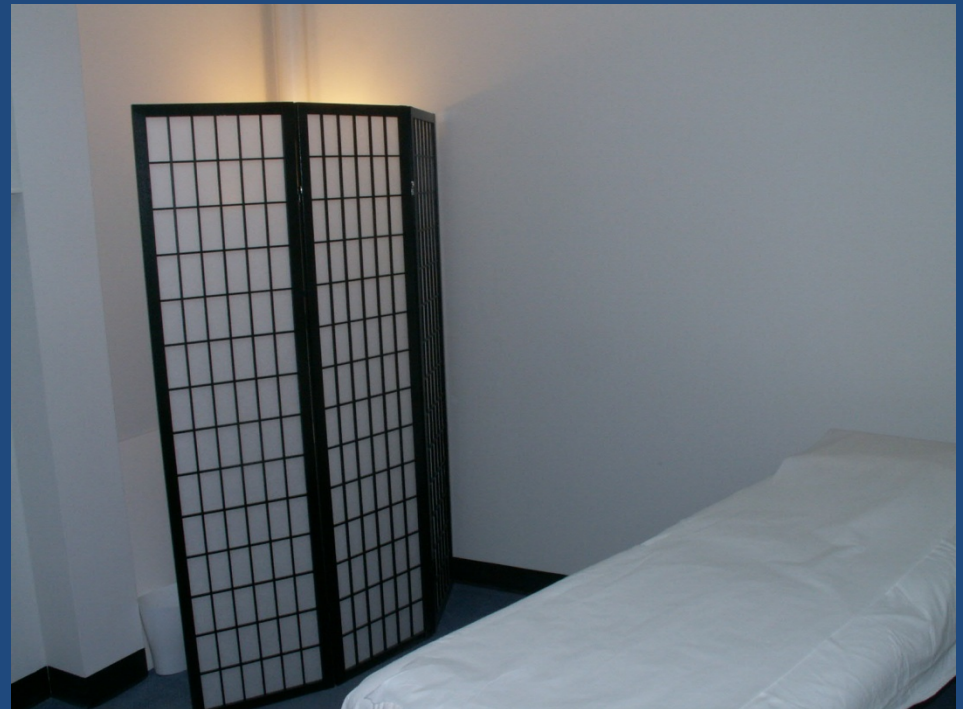
- 8 x 10 ft. minimum floor space.
- No windows or incandescent lights (fluorescent and LED lights OK).
- 68-70°F with no air drafts (the screen blocks drafts from AC).
- Clothes hooks and a shelf for jewelry, glasses, etc. for the subject to disrobe.
- Mirror for dressing after the session.
- No reflective surfaces or warm spots in the background of the thermograms.

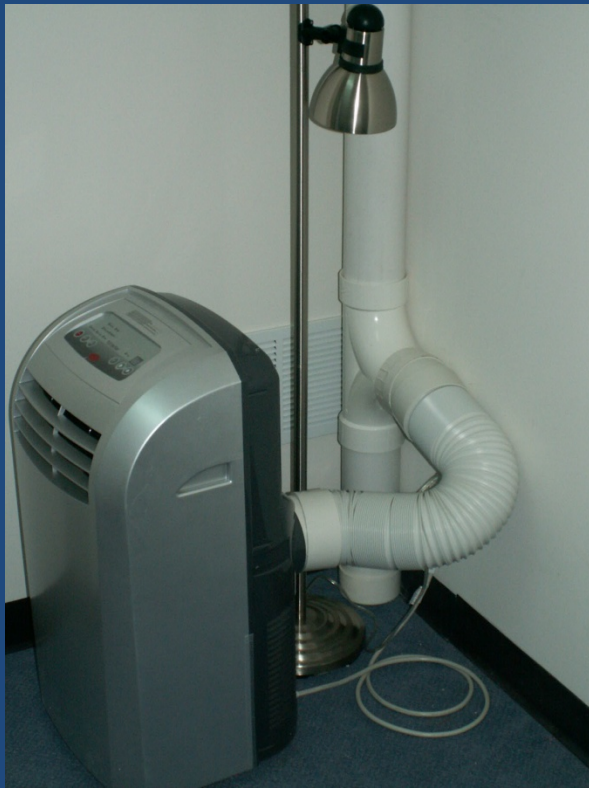
- A small in-room air conditioner “pumps” the heat out of the room.
- The heat is exhausted out into the space above the dropped ceiling in this example.
- Replacement air is drawn into the room through the vent behind the AC Unit.

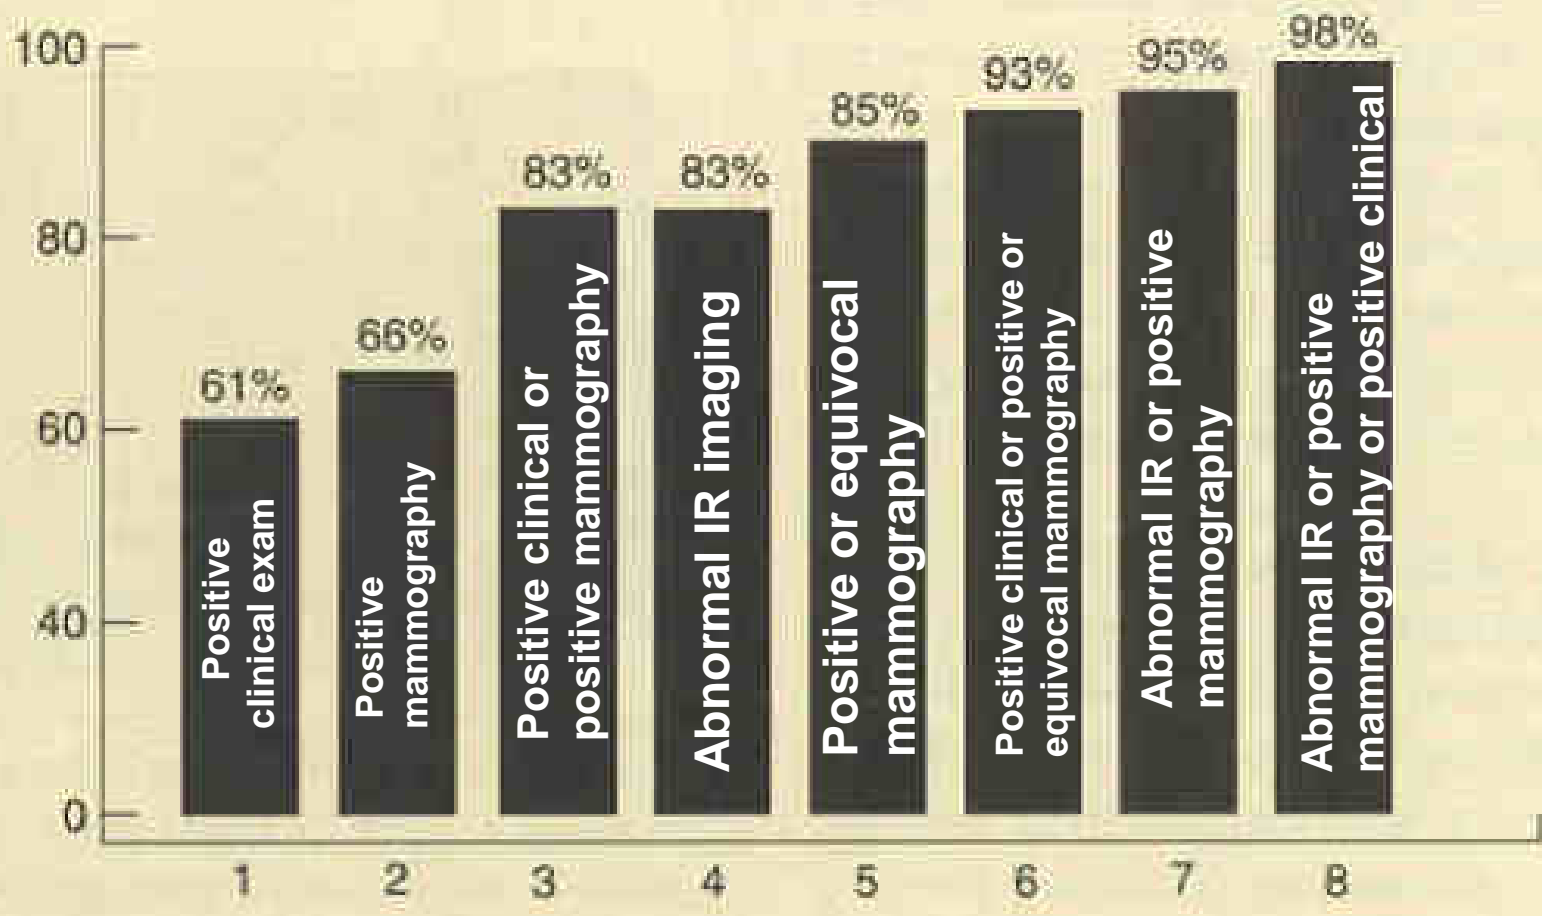
Relative sensitivity of clinical exam, mammography, and IR imaging in 100 cases of DCIS, Stage 1 and Stage 2 breast cancer – The Ville Marie Study.

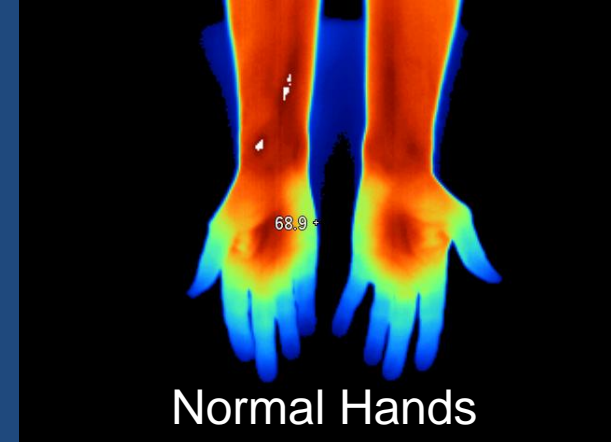
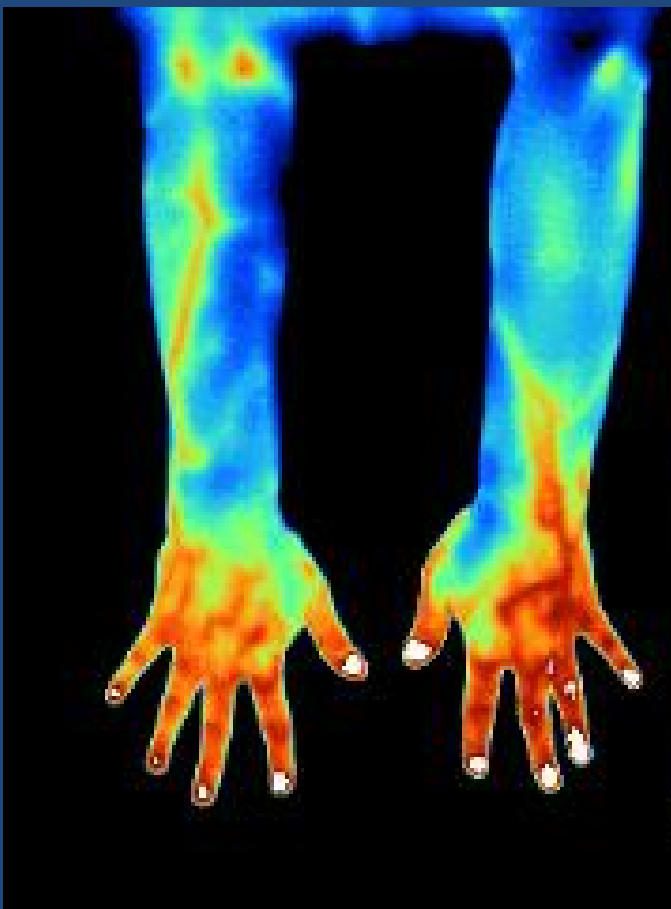
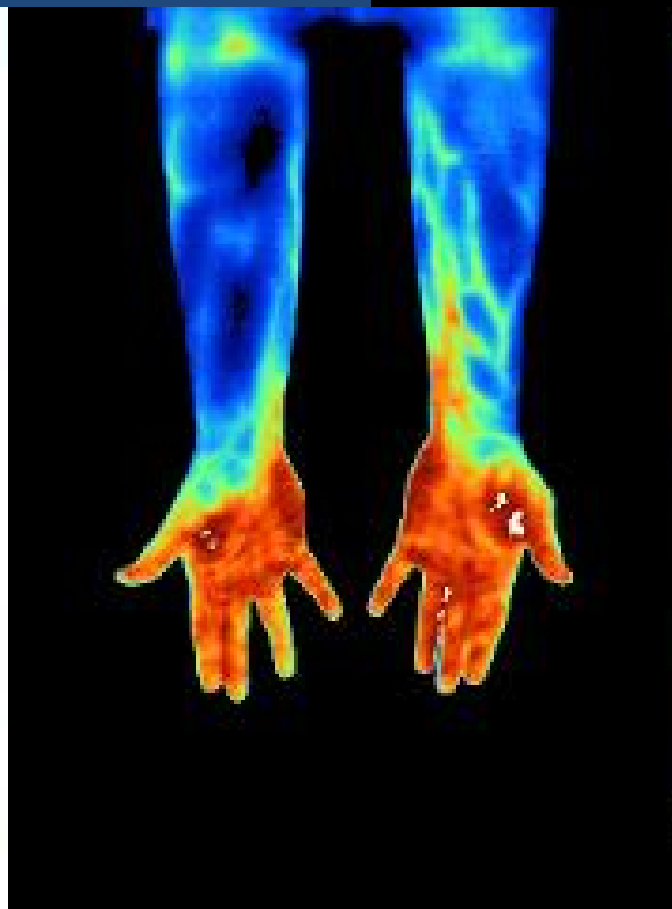
Vasculitis affecting the hands in a cooled individual

Note the “blotchy” warm palm pattern,
the hot fingernails, and
the warm returning veins.
